# ceramic implants

**international magazine of** ceramic implant technology

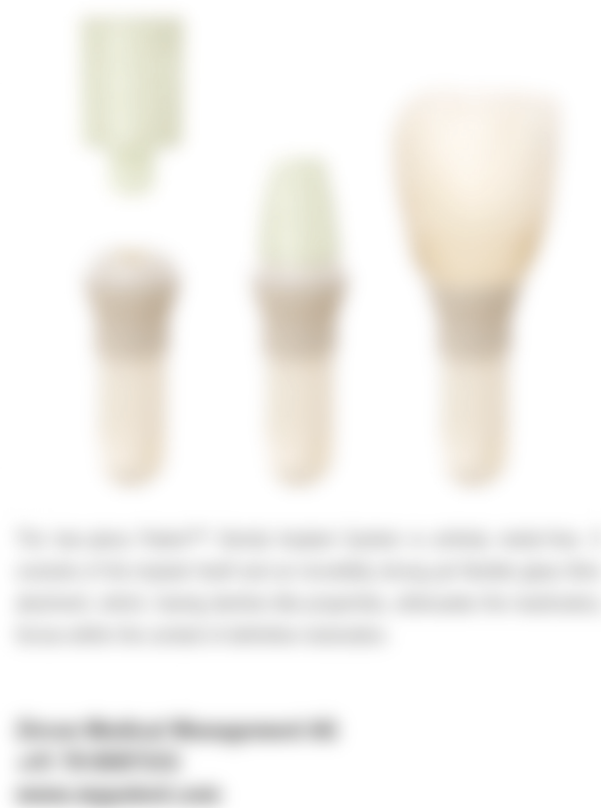
The PAPER® Dental Implant System is a revolutionary new concept in dental implantology. It is designed to provide a secure and stable foundation for dental restorations, while also promoting natural bone growth and healing. The system consists of a series of interconnected components, including a base implant, a neck, and a crown. The base implant is made of a highly durable, biocompatible material, and is designed to be inserted into the jawbone. The neck is made of a soft, flexible material, and is designed to provide a natural-looking appearance. The crown is made of a high-quality ceramic material, and is designed to provide a natural-looking appearance. The PAPER® Dental Implant System is a truly innovative solution for dental implantology, and is sure to revolutionize the way we think about dental implants.

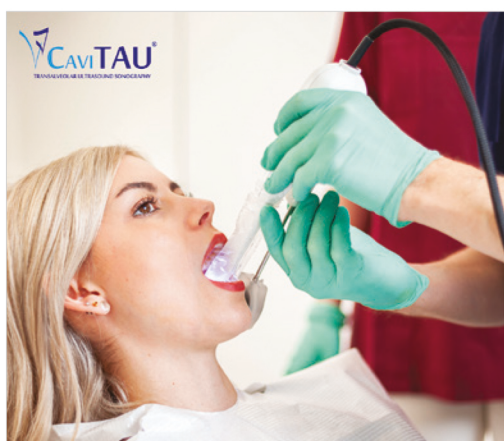
CaviTAU® application with LED gel pad and schematic representation of transalveolar sonography.
